NBSIR 87-3574

Wear Due to Printing Inks

L. K. Ives, M. Peterson, A. W. Ruff, J. S. Harris, and P. A. Boyer

FINAL REPORT

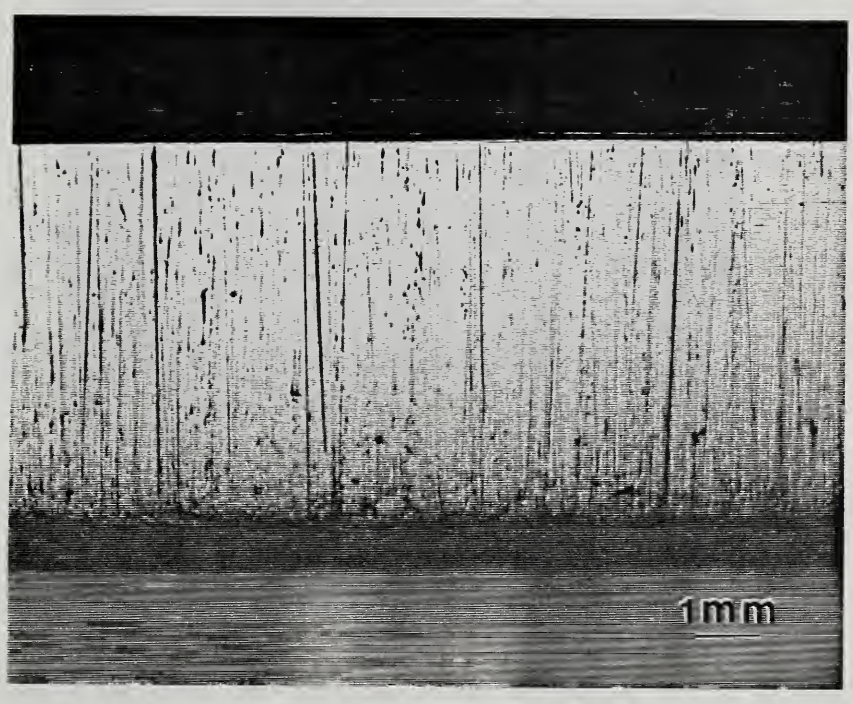
Figure 4. Photograph of the worn surface of a wiper blades showing abrasive wear scratches.

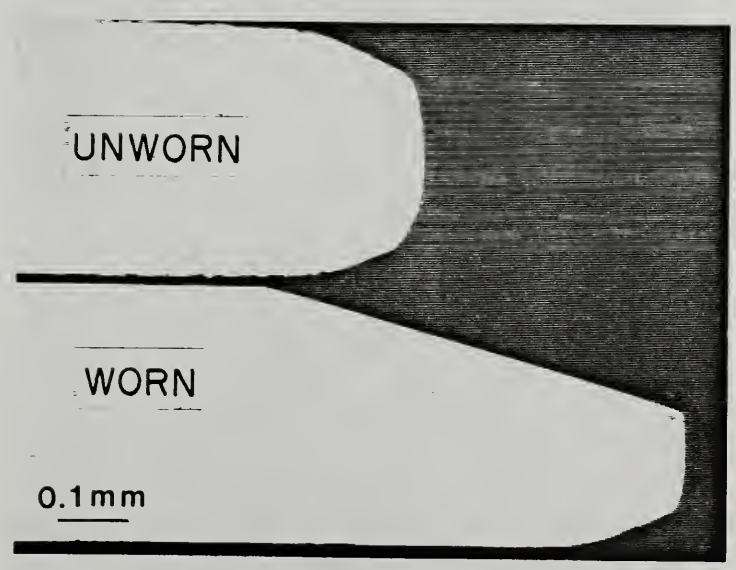
The wear of each blade was determined by measuring the wear scar width (Fig. 5) and using this value to determine wear volume from geometrical considerations. Actually, the wear scar width was found to vary along the length of the blade as shown in Fig. 6. Higher wear occurred at the blade ends than in the center. For each blade the total volume was determined by adding the volumes calculated at 2 cm intervals along on the blade. The specific wear (wear volume/impression) for each blade is shown in Fig. 7. An average value for the blades was 13.8×10^{-5} mm^3/impression.

Figure 5. Photographs of the cross sections of worn and unworn wiper blades.

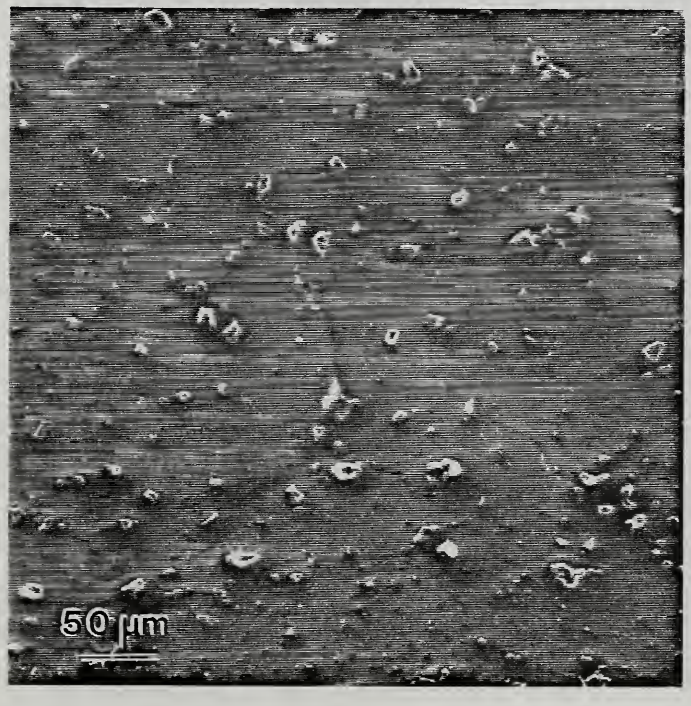
Photographs of the worn PVC surface are shown in Fig. 9 and 10. Several features can be seen: cracks and pitting both of which are probably due to the wear process. Another feature is that the particles seem to be raised above the PVC matrix. This would take place if they wore at a slower rate than the PVC. In other words, the PVC is being abraded from around the harder solid particles.

Figure 9. Photograph of a worn PVC wiping roll surface after use in service.

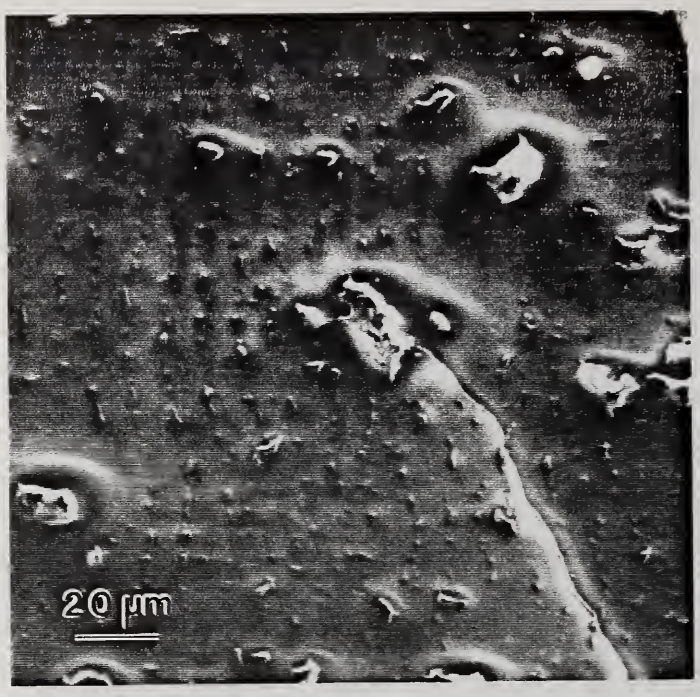
Figure 10. Photograph of a worn PVC surface showing cracks and particles.

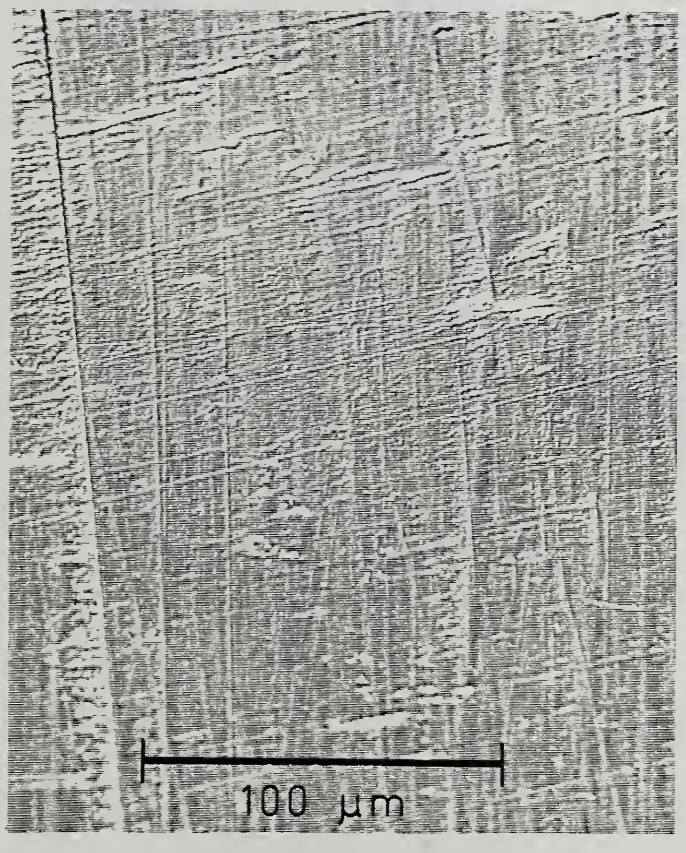
Figure 16. Photograph of chromium plated surface showing transfer of amorphous silica particles.

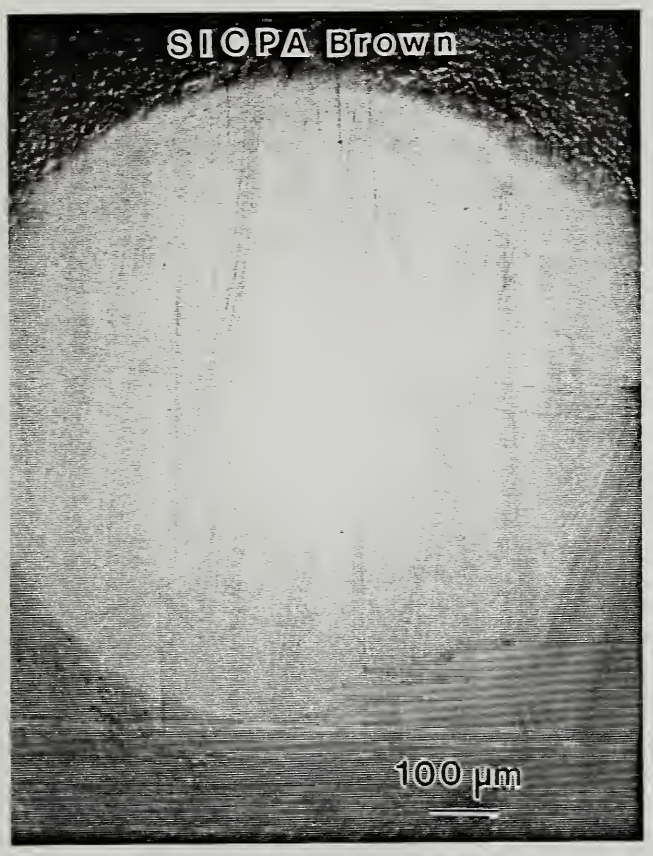
For stamp inks a correlation was established between service behavior and laboratory results. An ink that caused severe scratching in service was also found in laboratory tests to produce severe scratching of chromium plating. It was noted that severe scratching did not necessarily correlate with a high wear rate.

Figure 31. Photographs of wear scars on chromium plated pins after test runs with three intaglio stamp inks. Note differences in scratching produced by each ink.

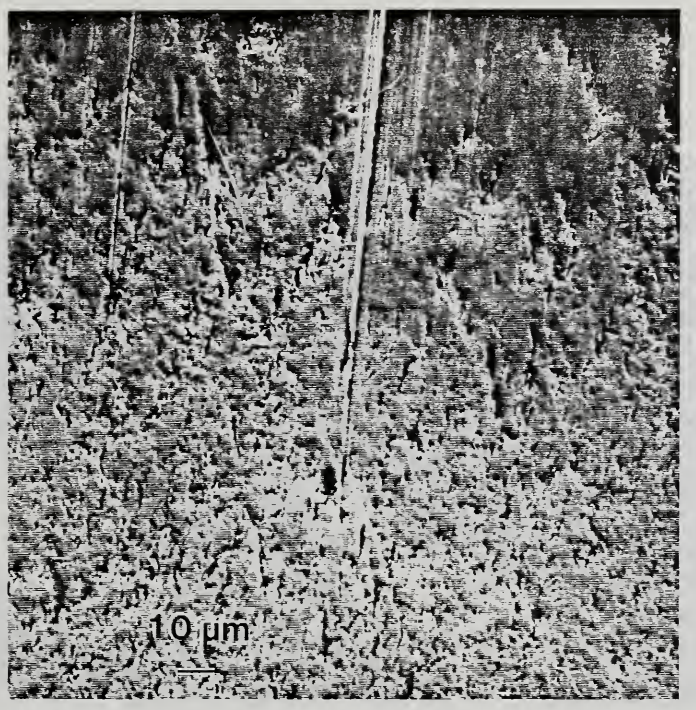
Figure 38. Optical photograph of entrance zone of wear scar on specimen from flat-on-ring test.

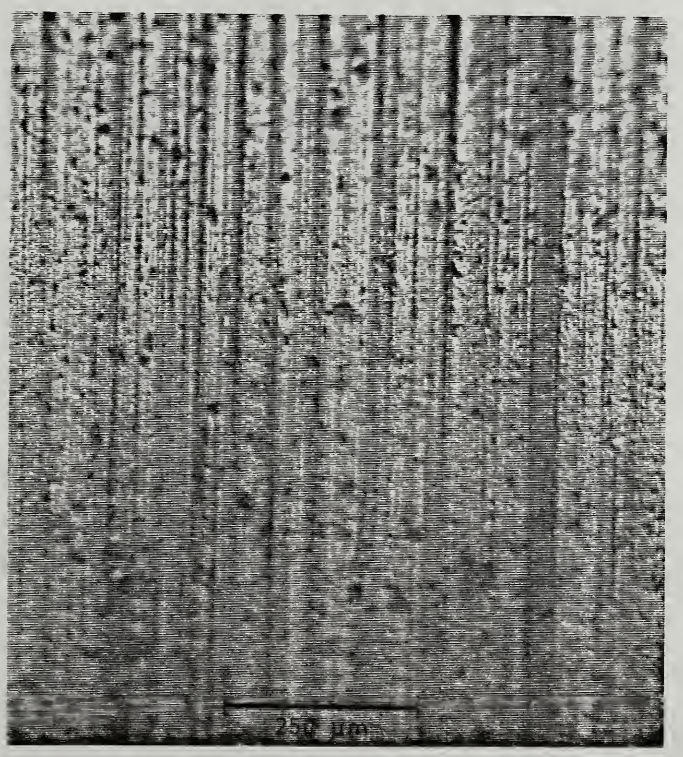
Figure 39. Optical photograph of surface of PVC ring from flat-on-ring test.

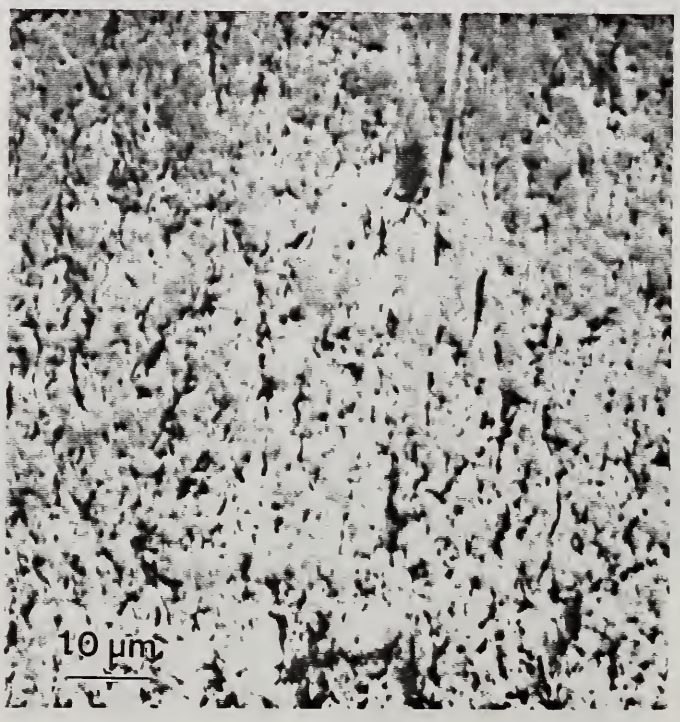
Figure 41. Scanning electron micrograph of entrance zone of wear scar from flat-on-ring test showing indentation damage produced by hard particles.
